I-35/SH-7 Subsurface Investigation

FINAL REPORT

ODOT TASK ORDER NUMBER 2160-20-06

School of Civil Engineering and Environmental Science (CEES)
The University of Oklahoma

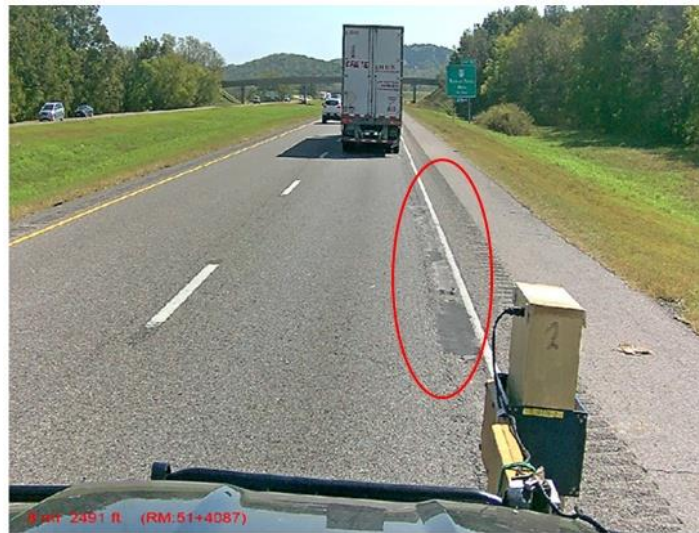
Figure 1.1 Longitudinal edge cracking observed on I-35

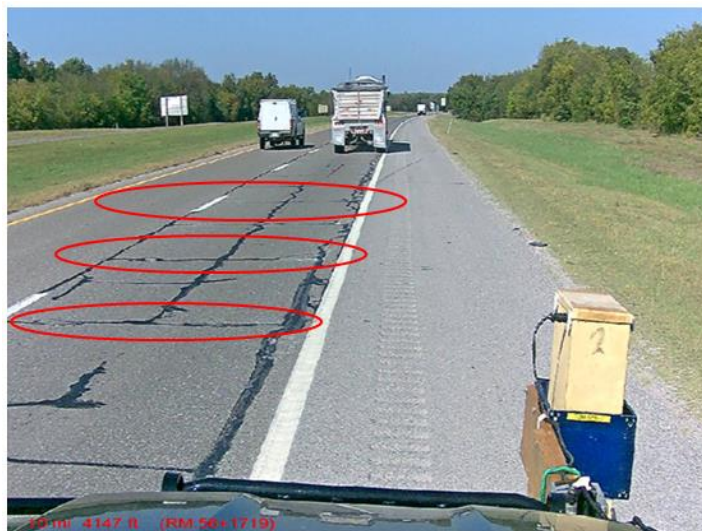
Figure 1.2 Reflective cracking observed on I-35

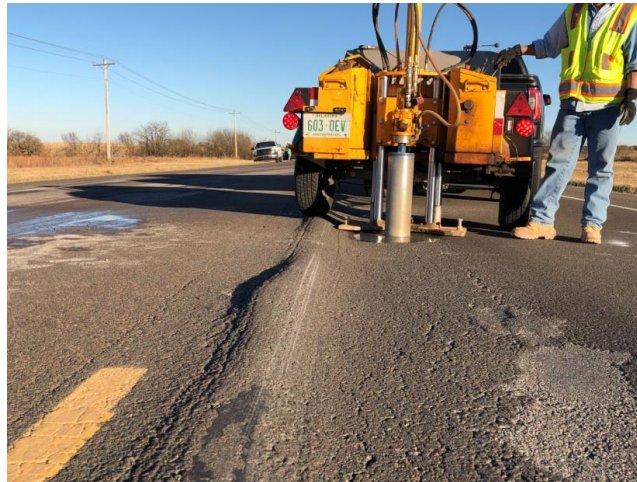
Longitudinal depressions in the form of rut near the centerline were observed on the SH-7 section located approximately 6 miles west of I-35 heading east approximately 5 miles in Garvin county (ODOT District 7). Figure 1.3 shows a photographic view of the excessive rut observed on SH-7. Figure 1.4 shows a loose or delaminated fabric layer not attached to the pavement below, causing shear failure in the upper Hot Mix Asphalt (HMA) layer. It is also a likely cause of rut.

Figure 1.3 Photographic view of rut observed on SH-7

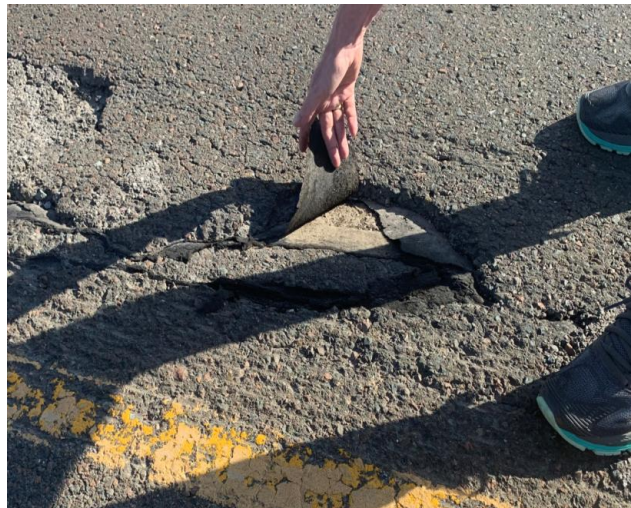
Figure 1.4 Photographic view of delaminated fabric layer on SH-7

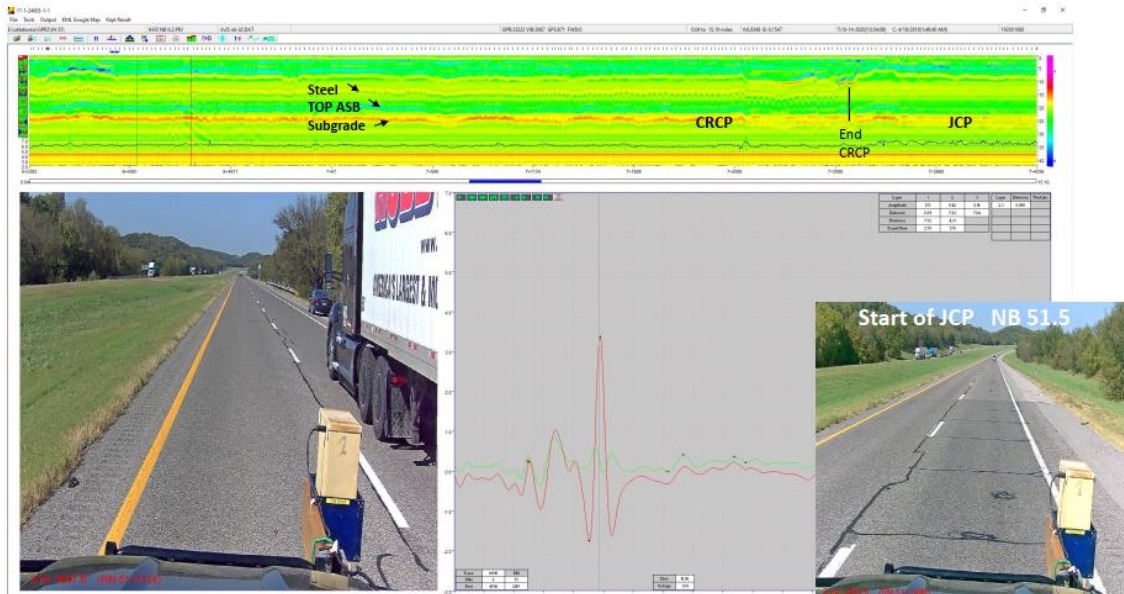
The collected GPR data were sorted, filtered, and analyzed using the software developed by TTI. The GPR data were then used to determine the layer thicknesses, presence of moisture, voids, stripping and other anomalies in the asphalt pavement, which could be responsible for the pavement distresses. The GPR results were used to identify areas for extraction of cores. Figure 2.2 shows an example of the GPR results from the north-bound lane of I-35. On Mile Post 51.5, the GPR images showed the end of the Continuously Reinforced Concrete Pavement (CRCP) section and the beginning of the Jointed Concrete Pavement (JCP) section. The GPR images did not detect any presence of reinforced steel anymore, and reflection cracking started to appear in this segment.

Figure 2.2 GPR and video images from north-bound I-35 section near Mile Post 51.5

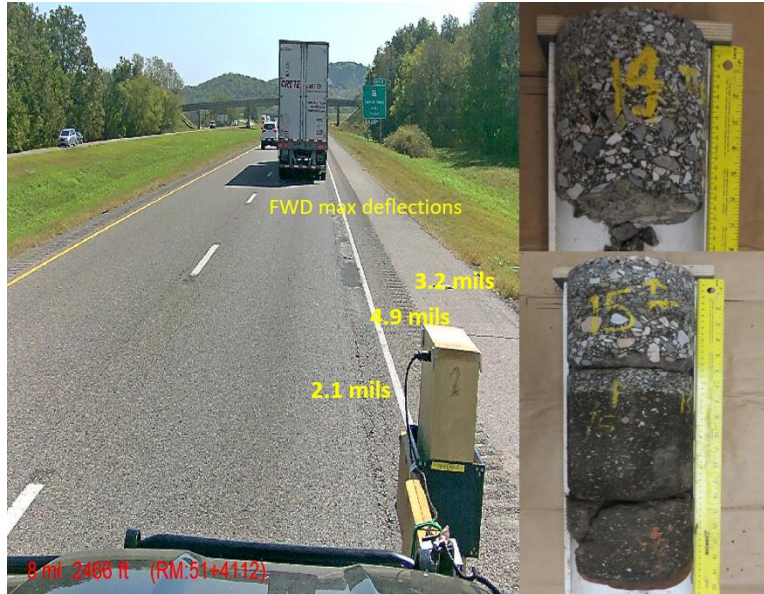
The main distresses observed south of Mile Post 51.5 (CRCP) were longitudinal edge cracking and edge failure. Also, some surface raveling and edge failure were observed. North of Mile Post 51.5 (JCP), the main distresses observed were reflection cracking and longitudinal edge cracking. The main cause of longitudinal edge failure is the presence of joint between the shoulder and lane inside the stripe paint. The pavement section in this segment consisted of 6 inches of HMA over CRCP. The shoulder section consisted of 6 inches of HMA over sand asphalt. Therefore, truck loads right at the joint or close to the joint are expected to cause higher deflections and failures. Figure 2.3 shows the difference between the lane and shoulder segments and the FFWD deflections.

Figure 2.3 Lane and shoulder segments of I-35 near Mile Post 51.5 and extracted cores

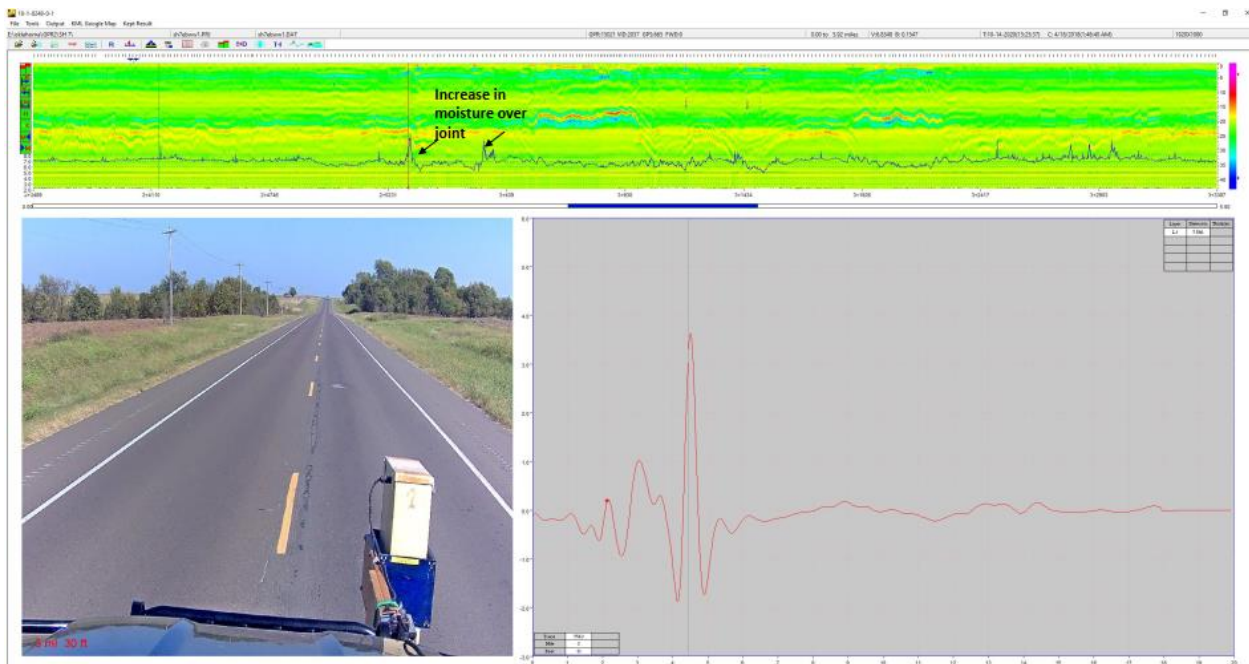
Figure 2.4 shows the GPR data collected from the east-bound lane of SH-7. As noted above, the GPR data exhibited an increase in moisture over the joint indicating infiltration of water through the longitudinal joint crack.

Figure 2.4 GPR and video images from east-bound SH-7 section

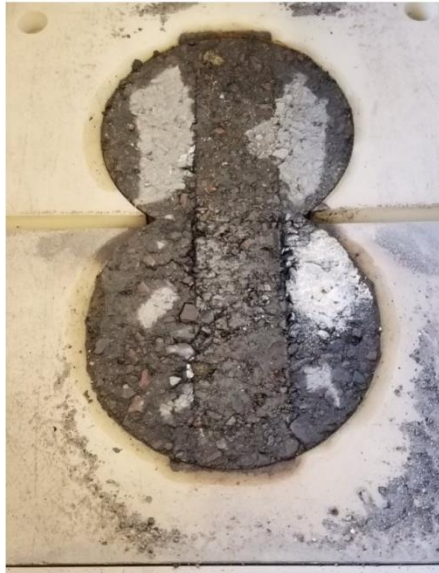
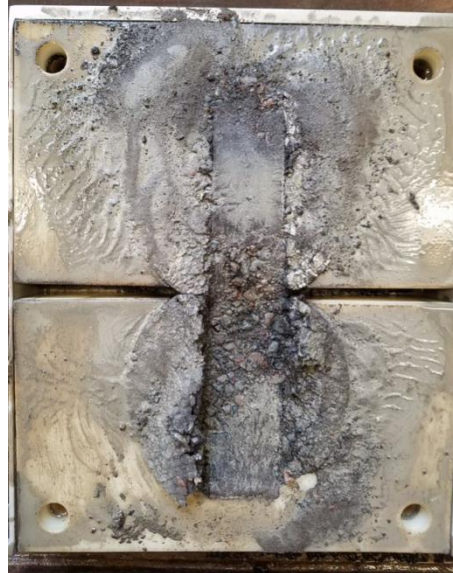
The Cores 22/23 performed well in rut and no stripping inflection point was observed (Figure 3.6 (a)). The Cores 24/25, however, did not pass the minimum requirement for rut (<12.5 mm for 20,000 passes). Also, stripping inflection point, which is an indicator of moisture-induced damage, was observed at 2,500 cycles (Figure 3.6 (b)). Figure 3.7 shows delamination of Core 24 (next to longitudinal joint) prior to testing. No other tested cores showed delamination in the top lift.

Figure 3.6 Photographic views of cores after HWT tests: (a) Cores 22/23; (b) Cores 24/25

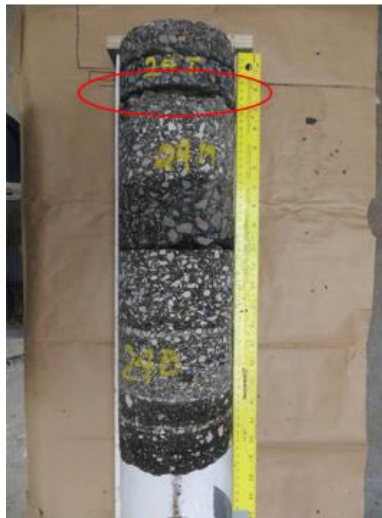
Figure 3.7 Delamination observed in Core 24

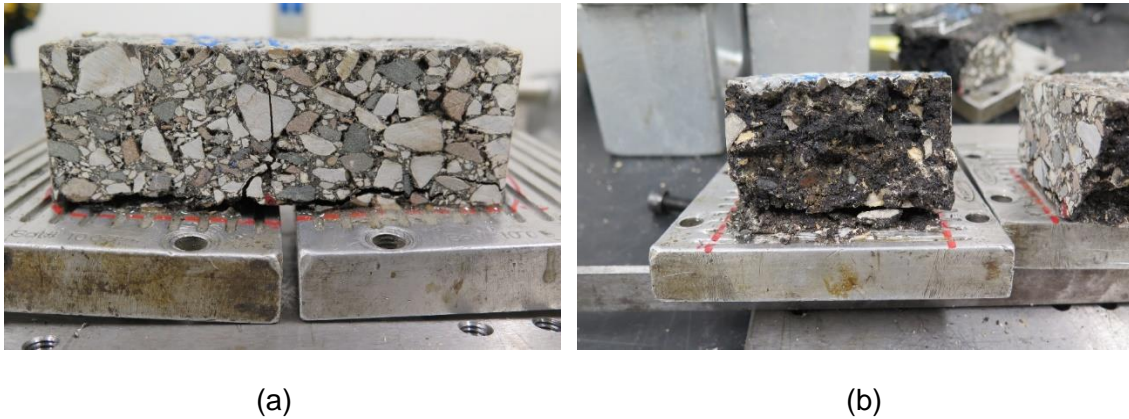
Texas Overlay Tests were conducted on the top and bottom sections of Cores 5 and 6 extracted from the I-35 section. Table 3.3 presents the results showing very poor resistance to cracking. The top specimens were collected from the top 0 to 1.5 inches of the extracted cores while the bottom specimens were taken from a depth of 1.5 to 3 inches from the surface. Figure 3.8 (a) and (b) show photographic views of the specimens before and after test. A very dry mix

condition was observed during testing. Generally, an asphalt mix with more than 300 cycles is expected to exhibit satisfactory resistance to fatigue cracking in the field. Based on these results, the resistance to fatigue cracking of the tested specimens was extremely low.

Figure 3.8 Samples (a) before and (b) after Texas Overlay Test

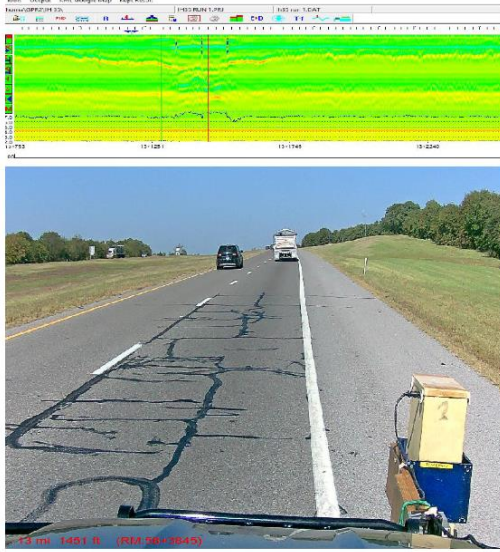
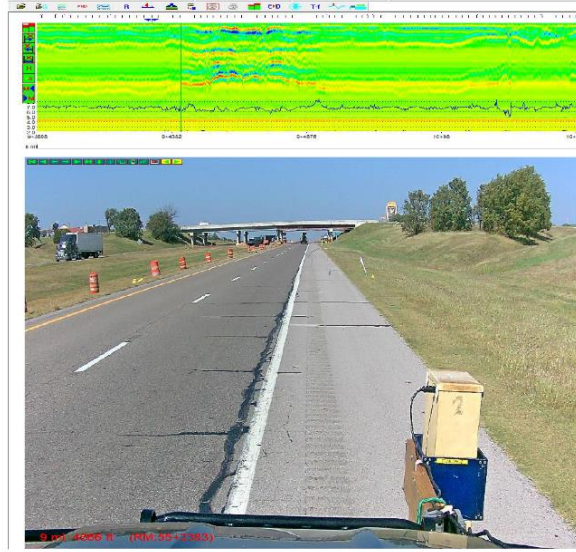
RM 58.6 looks like concrete shoulder

RM 55.4 looks like Flexible shoulder (joint inside white line)

Figure B.5 GPR on shoulders (Mile Post 58.6 and 55.4) of I-35

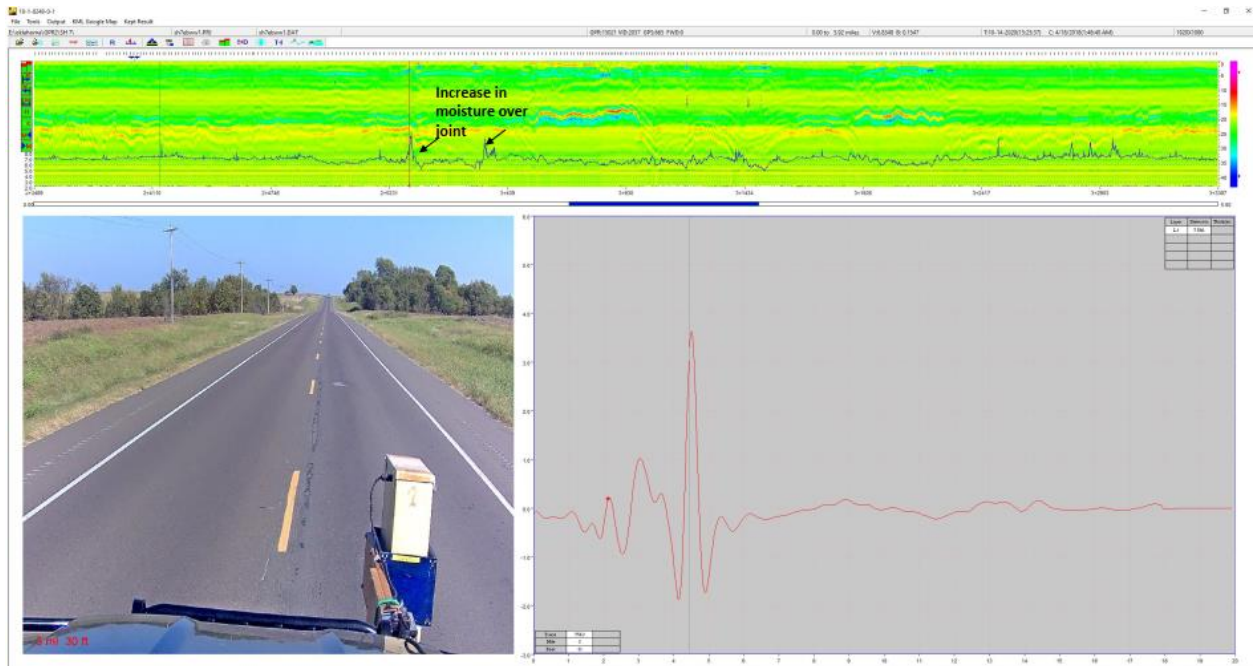
Figure B.7 GPR over rutted section on east-bound SH-7
