I-35/SH-7 Subsurface Investigation

FINAL REPORT

ODOT TASK ORDER NUMBER 2160-20-06

School of Civil Engineering and Environmental Science (CEES)
The University of Oklahoma

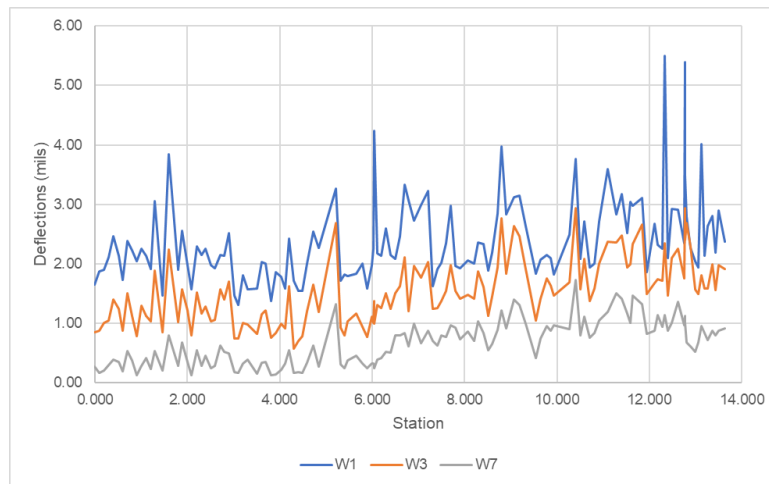
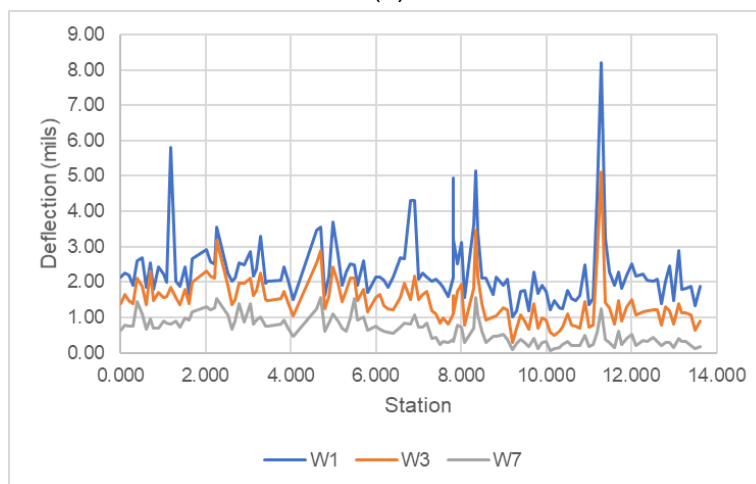
The air temperature during testing ranged from 31°F to 51°F, as per temperature data collected from the Mesonet site located at Paul's Valley. For the north-bound lane of I-35, FFWD tests were conducted at 124 locations. The highest W1 deflection was recorded as 5.5 mils. From these data, the average deflection was found to be 2.39 mils, with a standard deviation of 0.72 mils. Comparatively, FFWD tests at the south-bound lane of I-35 were conducted at 123 locations. The highest W1 deflection was recorded as 8.19 mils with an average of 2.32 mils and a standard deviation of 0.95 mils. For the east-bound and west-bound lanes of SH-7, a total of 56 locations were tested in each direction. For the east-bound lane, the highest W1 deflection was recorded as 5.2 mils with an average of 3.04 mils and a standard deviation of 0.75 mils. For the west-bound lane, the highest W1 deflection was 4.22 mils with an average of 3.10 mils and a standard deviation of 0.62 mils.

Figure 2.7 FFWD results for I-35 section: (a) north-bound lane; (b) south-bound lane

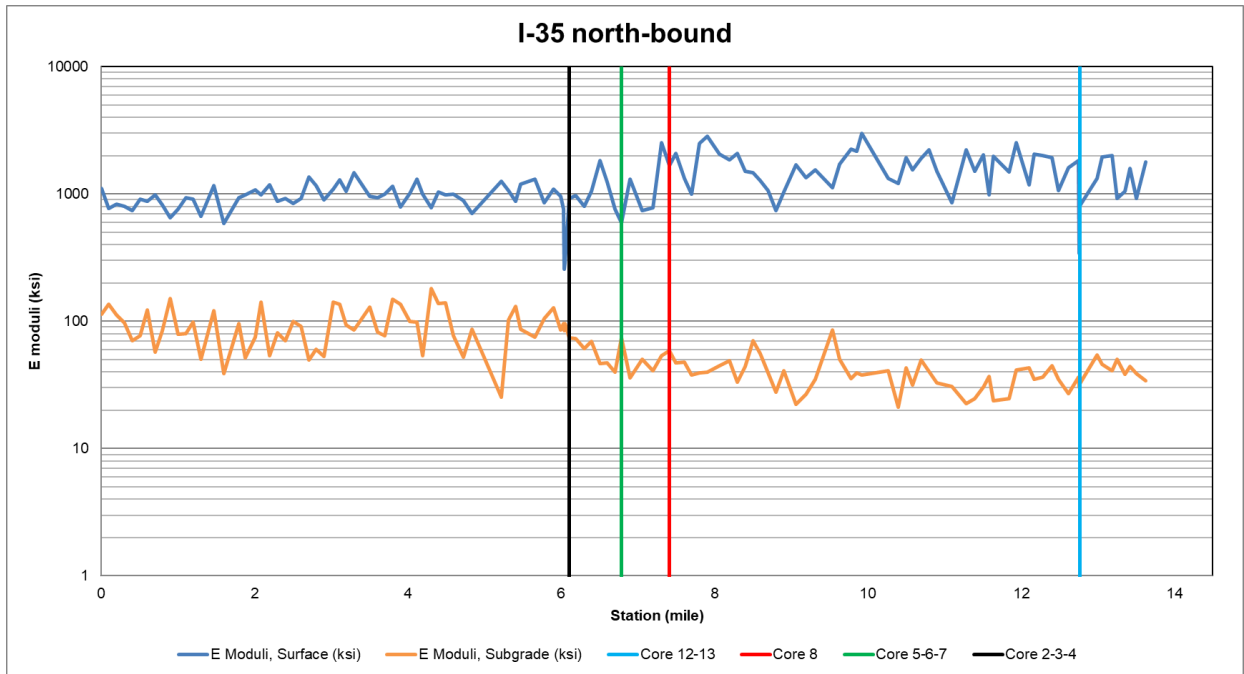
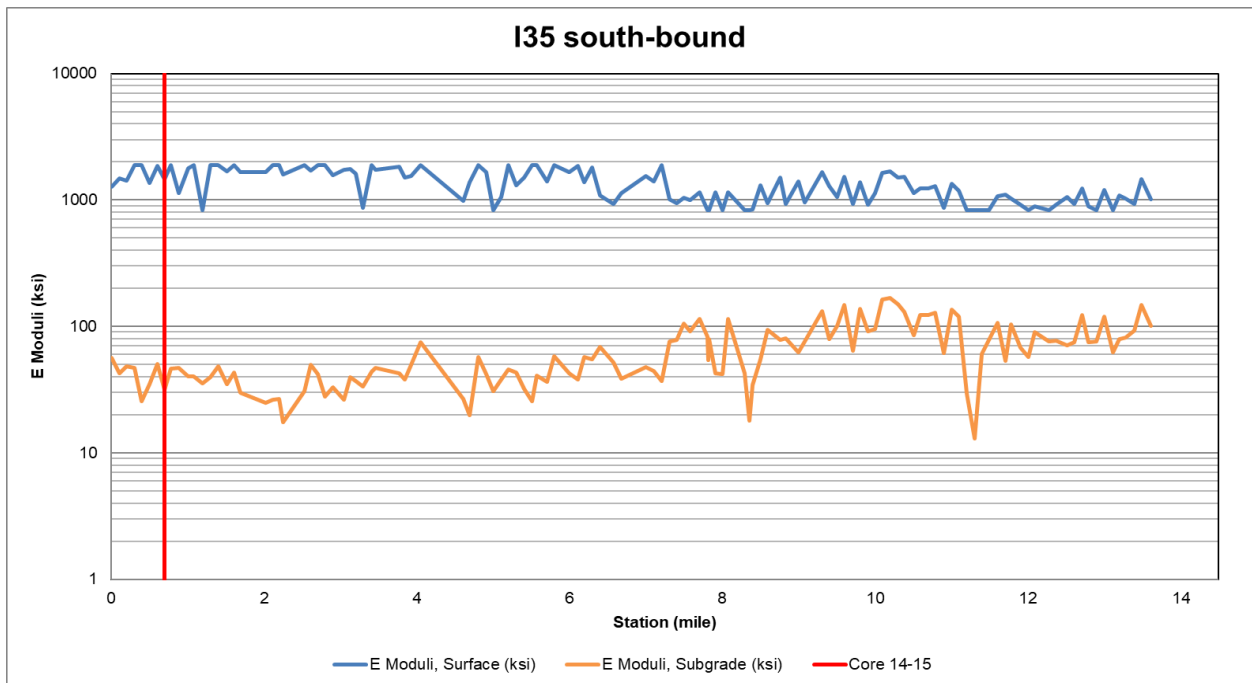
Figure 2.9 Elastic moduli (E) results for the I-35 section: (a) north-bound; (b) south-bound

For the I-35 section, the E values were found to be much higher, as expected. The mean and standard deviation were observed as 1,262.2 and 536 ksi, respectively, for the base layer and 66.3 and 35.7 ksi, respectively, for the subgrade in the north-bound lane of I-35. For the south-bound lane, the corresponding mean and standard deviation values were 1,332.2 and 383.2 ksi, respectively, for the surface layer and 65 and 35.3 ksi, respectively, for the subgrade. From laboratory testing, the E moduli of 918, 596, 1,674, 810 and 1,461 ksi were observed for cores 2-3-4, 5-6-7, 8, 12-3, and 14-15, respectively.

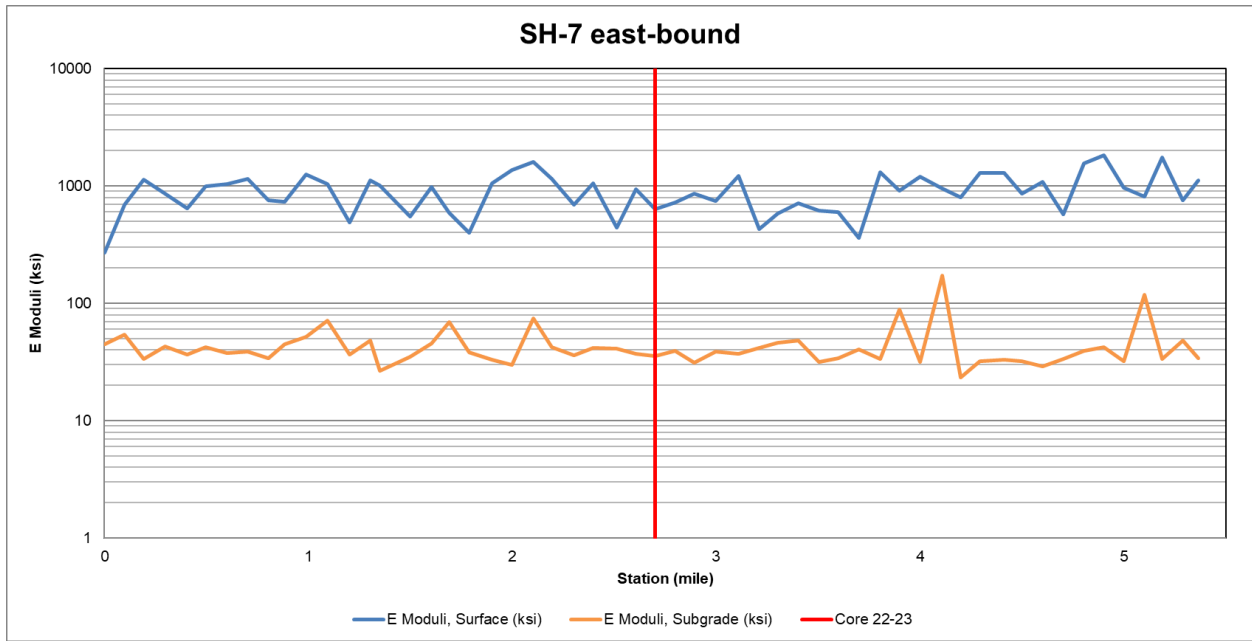
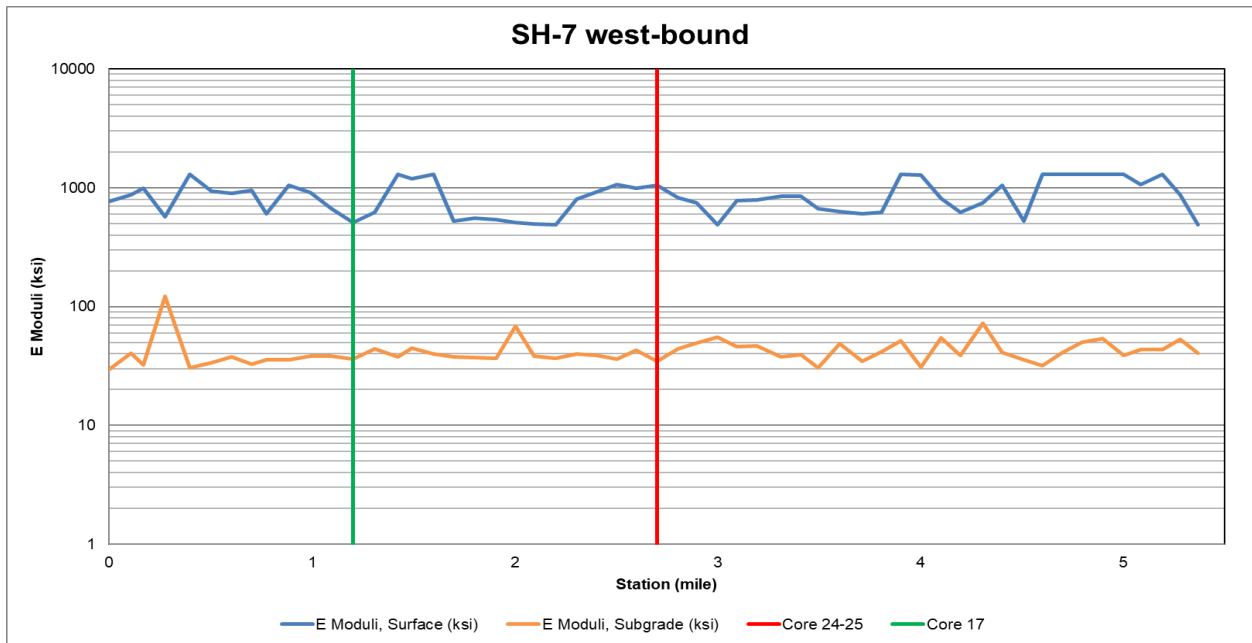
Figure 2.10 Elastic moduli (E) results for the SH-7 section: (a) east-bound; (b) west-bound

For the surface layer of the east-bound lane of SH-7, the mean and standard deviation of moduli were found as 919.7 and 346.4 ksi, respectively. For the subgrade layer, the corresponding values were found as 44.6 and 23.7 ksi, respectively. For the west-bound lane,

the corresponding mean and standard deviation were 866.6 and 277.7 ksi (for base layer) and 42.7 and 13.8 ksi (for subgrade layer), respectively. From laboratory testing, E values of cores 17, 22-23 and 24-25 were found to be 510, 636 and 1,052 ksi, respectively.

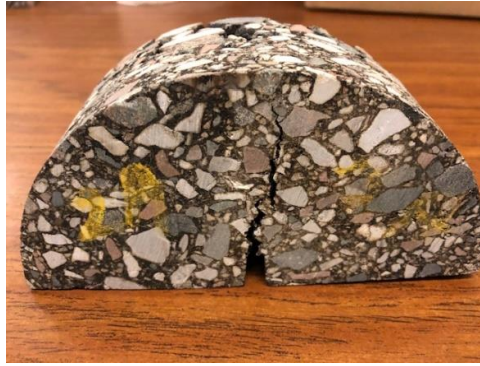
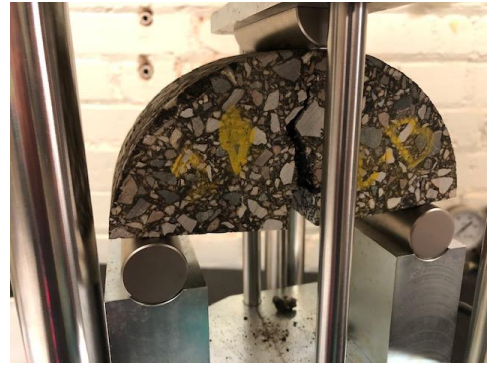
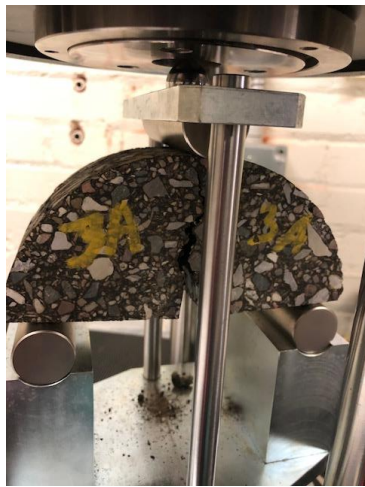
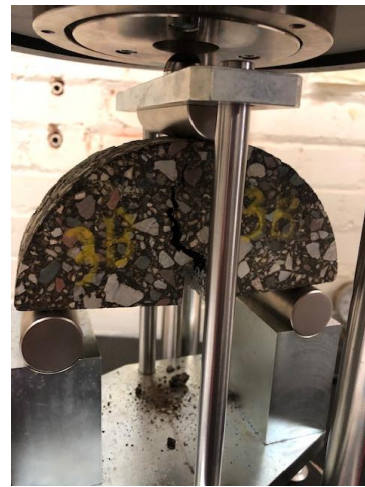
Semi-circular Bend tests were conducted on the extracted cores from I-35 to determine their resistance to fatigue cracking. The Illinois-Flexibility Index Test (I-FIT) was conducted in accordance with the AASHTO TP124 [10] method. For this purpose, a 40 mm thick layer was cut out from the top of the core. It was then cut into two semi-circular pieces and a notch of 15 mm depth was cut in each semi-circular piece. The test was conducted by applying a monotonic load at 50 mm/min until failure. The I-FIT test results are presented in Figure 3.3. The Flexibility Index (FI) values were found to be very low for samples 2A, 3A and 3B, and low for sample 2B compared to the acceptable limit (greater than 8). Photographic views of the tested samples are shown in Figure 3.4.

Figure 3.4 Photographic views of tested samples: (a) 2A; (b) 2B; (c) 3A; (d) 3B

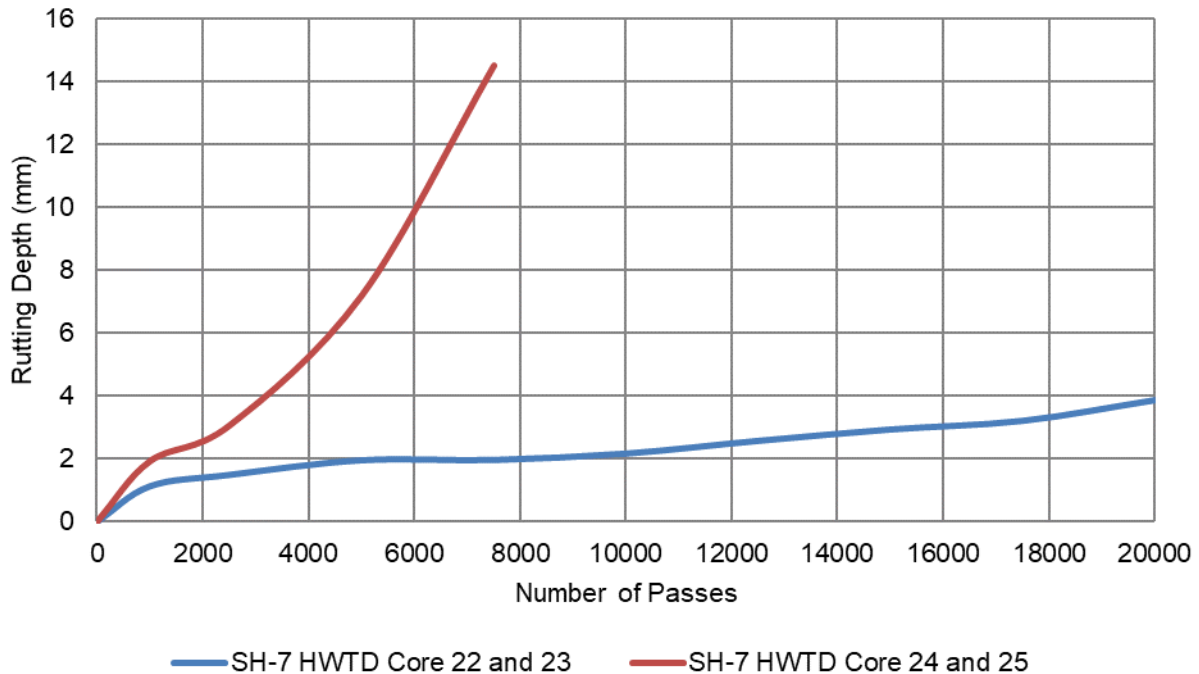
Hamburg Wheel Tracking (HWT) tests were conducted on the top lifts of the extracted cores from SH-7 following OHD L-55 [9] to determine their susceptibility to rut and potential for moisture-induced damage. The HWT tests were conducted at 50°C with a wheel pass frequency of 52 passes/minute. The tests were terminated after reaching a maximum rut depth of 20-mm or 20,000-wheel passes, whichever reached first. Figure 3.5 presents the HWT test results for Cores 22/23 and Cores 24/25. Also, Table 3.2 summarizes the results of post-compaction, creep slope and maximum rut depth.

Figure 3.5 The HWT test results for Cores 22/23 and Cores 24/25

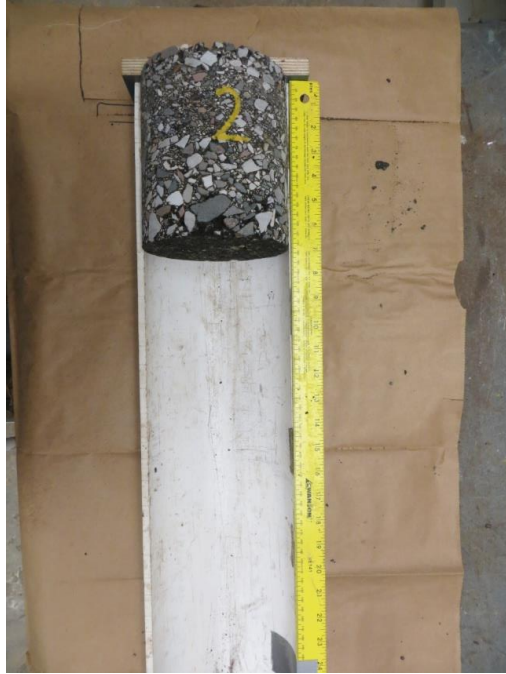
Figure A.1 Core #2 on I-35

Cores I-35	Latitude	Longitude	Direction	Core Notes
2	34.46068	-97.144701	NB	Mid-lane
3	34.46068	-97.144701	NB	2-ft. south of Core 2
4	34.46068	-97.144701	NB	Over shoulder, delamination and stripping
5	34.468844	-97.152298	NB	Mid-lane, thick tack and fabric
6	34.468844	-97.152298	NB	2-ft. south of Core 2, fabric
7	34.468844	-97.152298	NB	Mid. Shoulder, Delamination
8	34.477261	-97.156555	NB	1-ft. left of shoulder line, thick tack
12	34.550264	-97.190554	NB	Mid-lane over crack, filled crack, thick tack and delamination
13	34.550264	-97.190554	NB	2-ft. right of shoulder line, crack, delamination, stripping
14	34.550264	-97.190554	SB	Right wheel path
15	34.550264	-97.190554	SB	Shoulder line, delamination, stripping and fully cracked bottom layer
Cores SH-7	Latitude	Longitude	Direction	Core Notes
17	34.52051	-97.212729	WB	Right wheel path through crack, fabric
22	34.521305	-97.237975	EB	Right wheel path, fabric, delamination, stripping

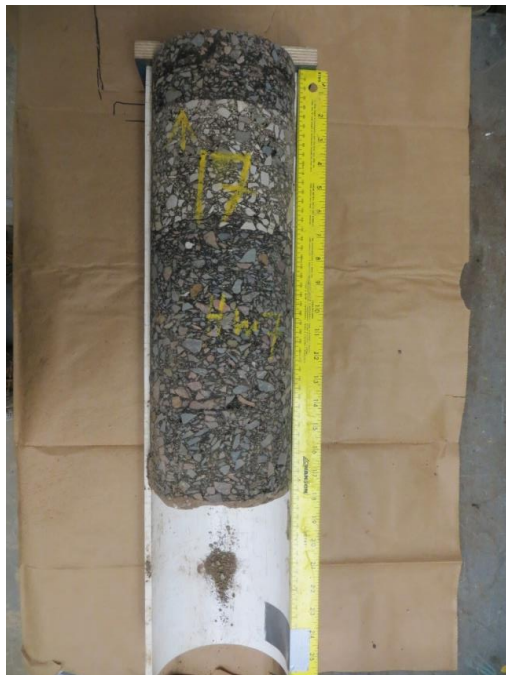
Figure A.12 Core #17 on SH-7

Cores SH-7	Latitude	Longitude	Dir.	Top Lift (mm)	HMA (mm)	Base (mm)	Total (mm)	Top Lift (in.)	HMA (in.)	Base (in.)	Total (in.)	Core Notes (mm)
Staging Area	34.50669	-97.17723	WB									
Begin	34.51004	-97.19488	WB									
17	34.52051	-97.21273	WB	25	447		447	0.98	17.60		17.60	RW thru crack. Cracked to Fab. 25.
22	34.52131	-97.23798	EB	32	390	35	425	1.26	15.35	1.38	16.73	RW. Fab. 32. Del. 225.
23	34.52131	-97.23798	EB	25	410	95	505	0.98	16.14	3.74	19.88	LW near CL in rutted area. Fab. 25. Some strip to 40. Del. 235. **Stripping in core hole from 50 to 100.
24	34.52131	-97.23798	WB	32	440	80	520	1.26	17.32	3.15	20.47	LW over crack. Fab. 32. Del. and some strip at 75 and 260.
25	34.52131	-97.23798	WB	33	435	70	505	1.30	17.13	2.76	19.88	RW. Fab. 33. Del. 67 and 345.
End	34.52134	-97.28487

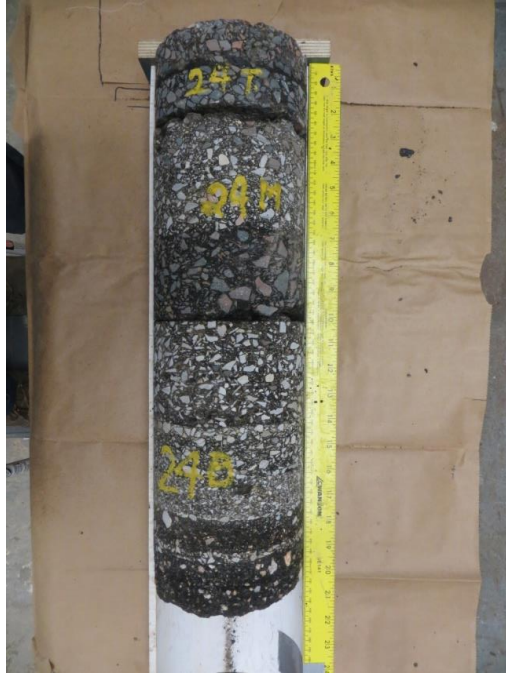
Figure A.15 Core #24 on SH-7

Figure 3.7 Delamination observed in Core 24

- i. Cold mill up to 2-in. of existing pavement and replace with 2-in. of Stone Matrix Asphalt (SMA) (PG 64E-28), or
 - ii. Cold mill up to 2-in. of the existing pavement and replace with 2-in. of S4 (PG 64E-28)

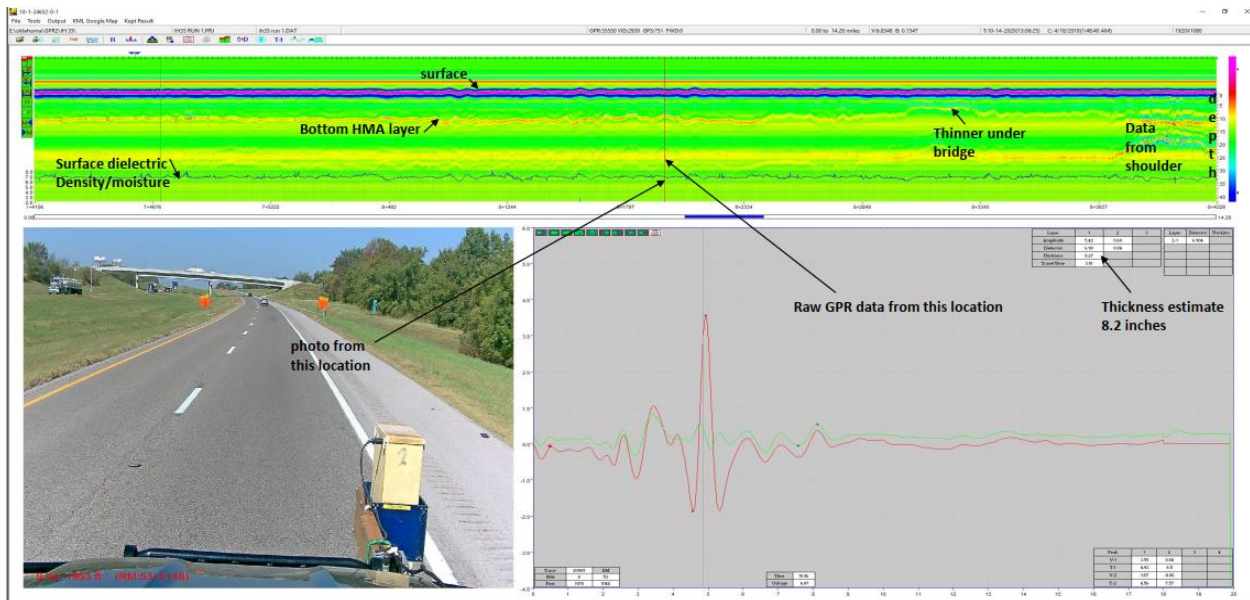
Figure B.1 Raw GPR data for a 1-mile (approximately) section of north-bound I-35

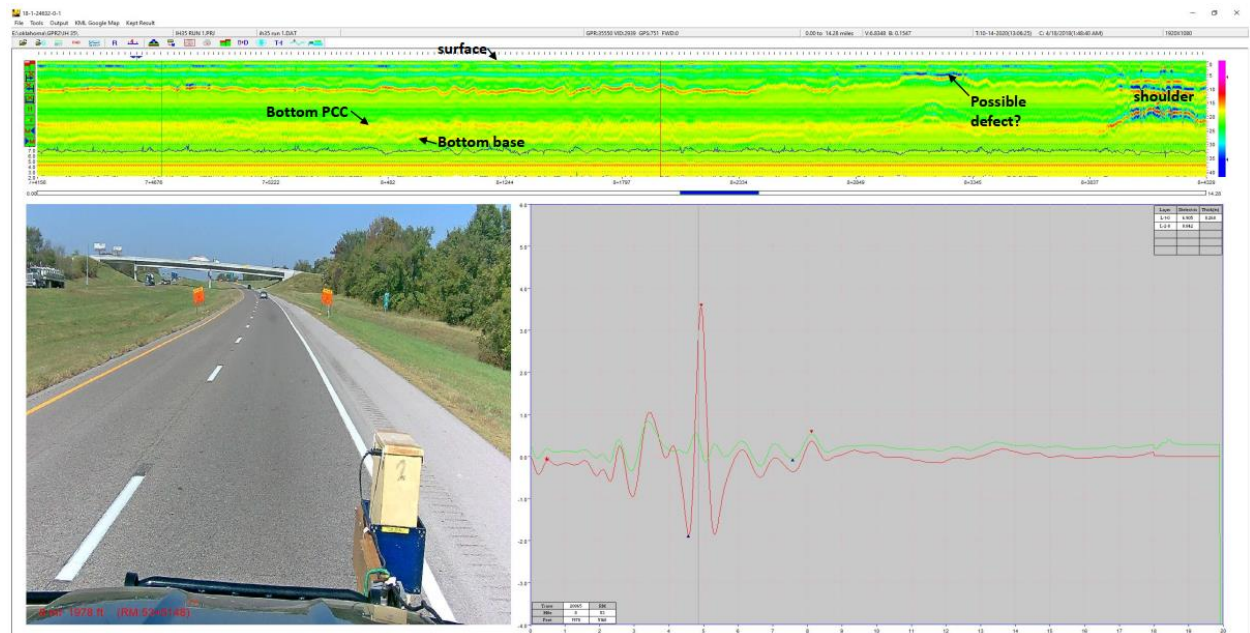
Figure B.2 Removing the surface to highlight subsurface information of I-35

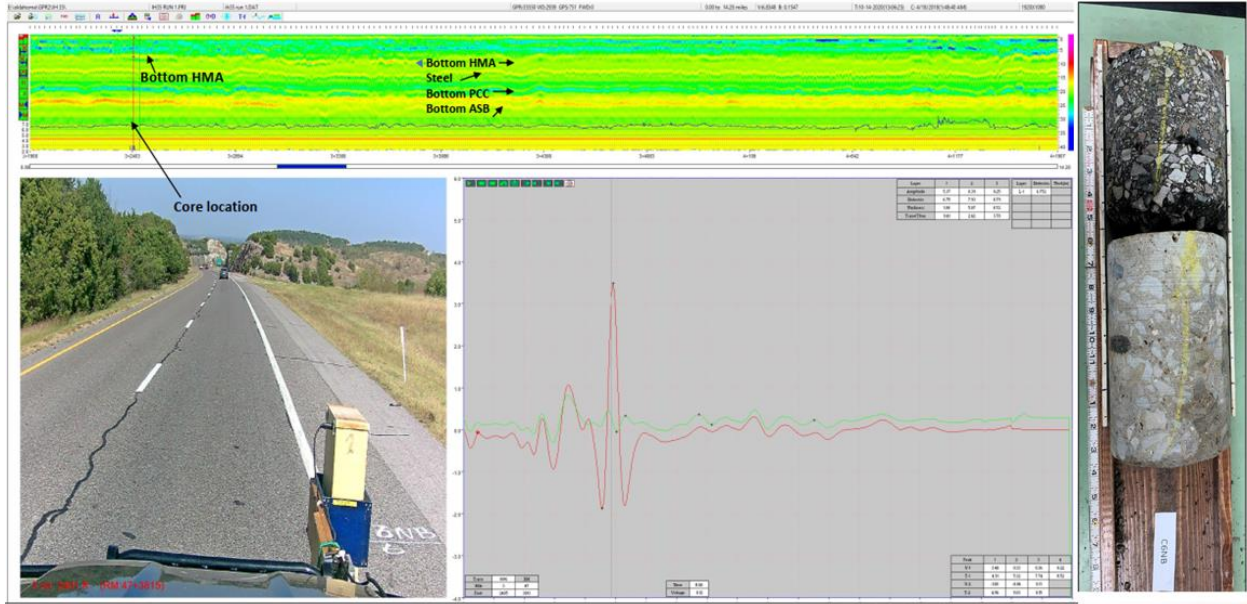
Figure B.3 Location of Core 6 from ODOT survey on I-35

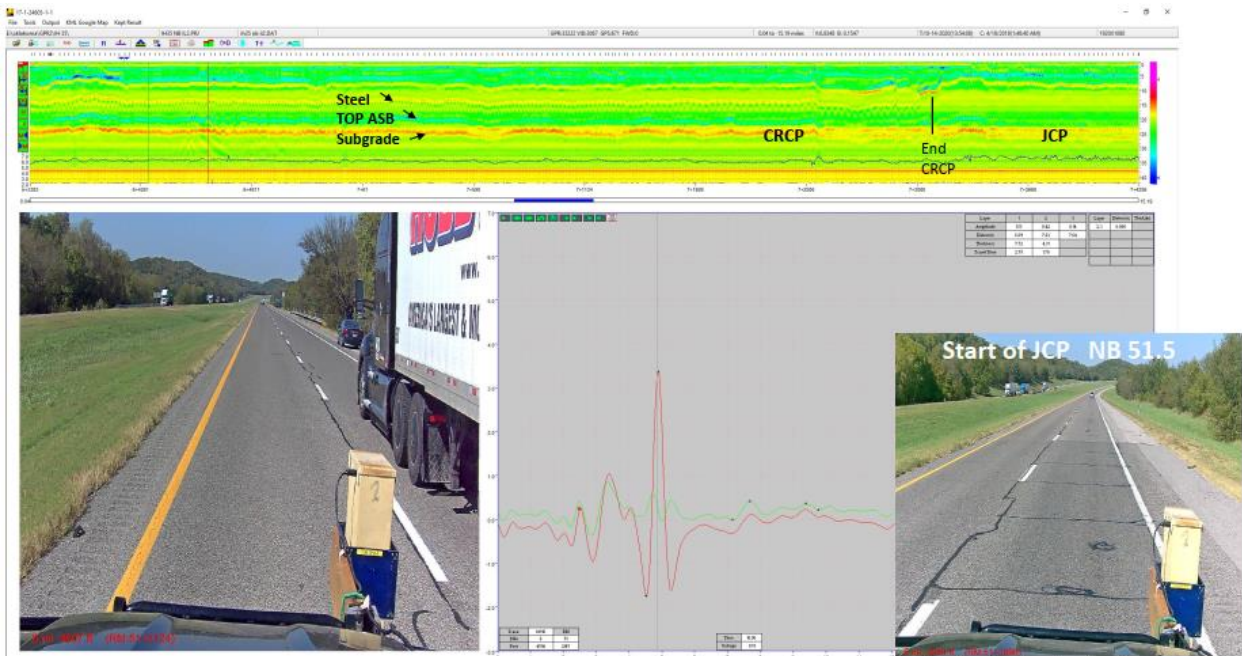
Figure B.4 Inside lane at transition from CRCP to JCP @ Mile Post 51.5 on I-35

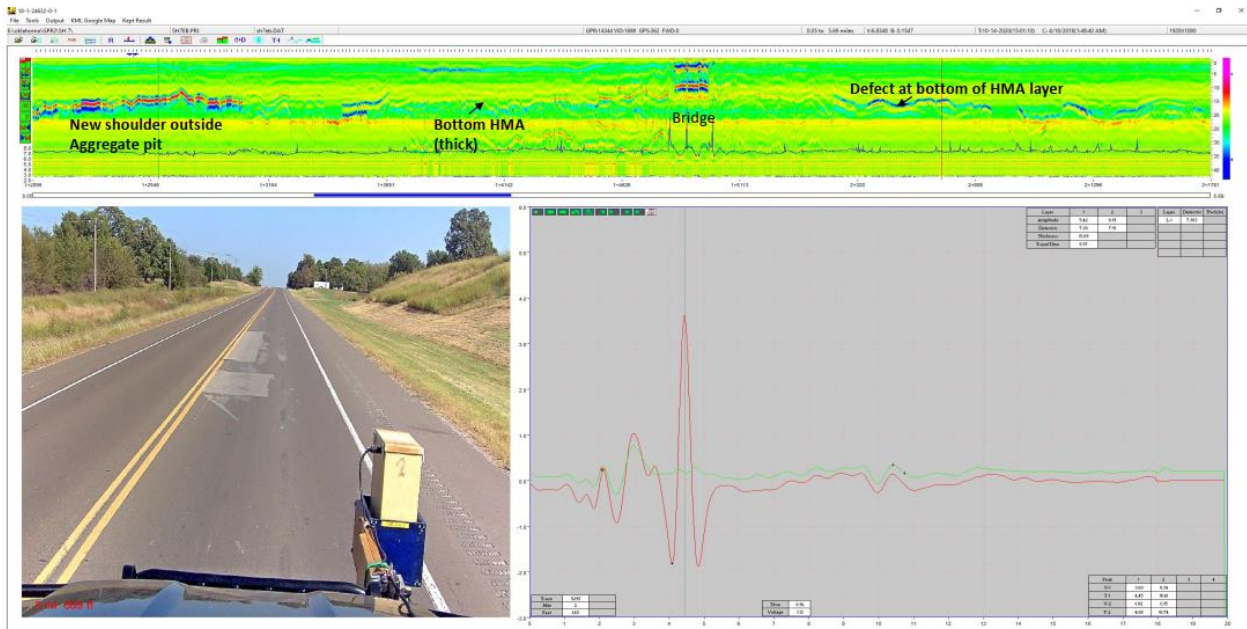
Figure B.6 GPR on west-bound lane of SH-7
